Leak Masters LLC

1/XX/13

Claim # XXXX-XXXX-XXXX

CLIENT I looked at this loss today, I did see the floor buckled in the front room and the kitchen area. I ran the infrared camera and found that the floor was very hot. I located a place starting in the kitchen and running out to the front door that showed a higher heat then the rest of the room. I spent considerable time trying to get the access door open to the crawl space. I did eventually get it open. I found a pvc hot water pipe that had split. This fitting looks to be the new piping for the remodel that the home had done some time ago. The fitting is connected to the copper  $\frac{3}{4}$  inch pipe that looks like the original piping. The line has a small split in it and is spraying water up to the underlayment for the first floor of the home. There was no insulation so the hot water would spray directly on the wood and it was very saturated. The renter did notice the floor having a buckling problem in December. The entire crawl space is very high in humidity, and dripping with moisture. I turned off the hot water tank and also turned the hot water tank to vacation.

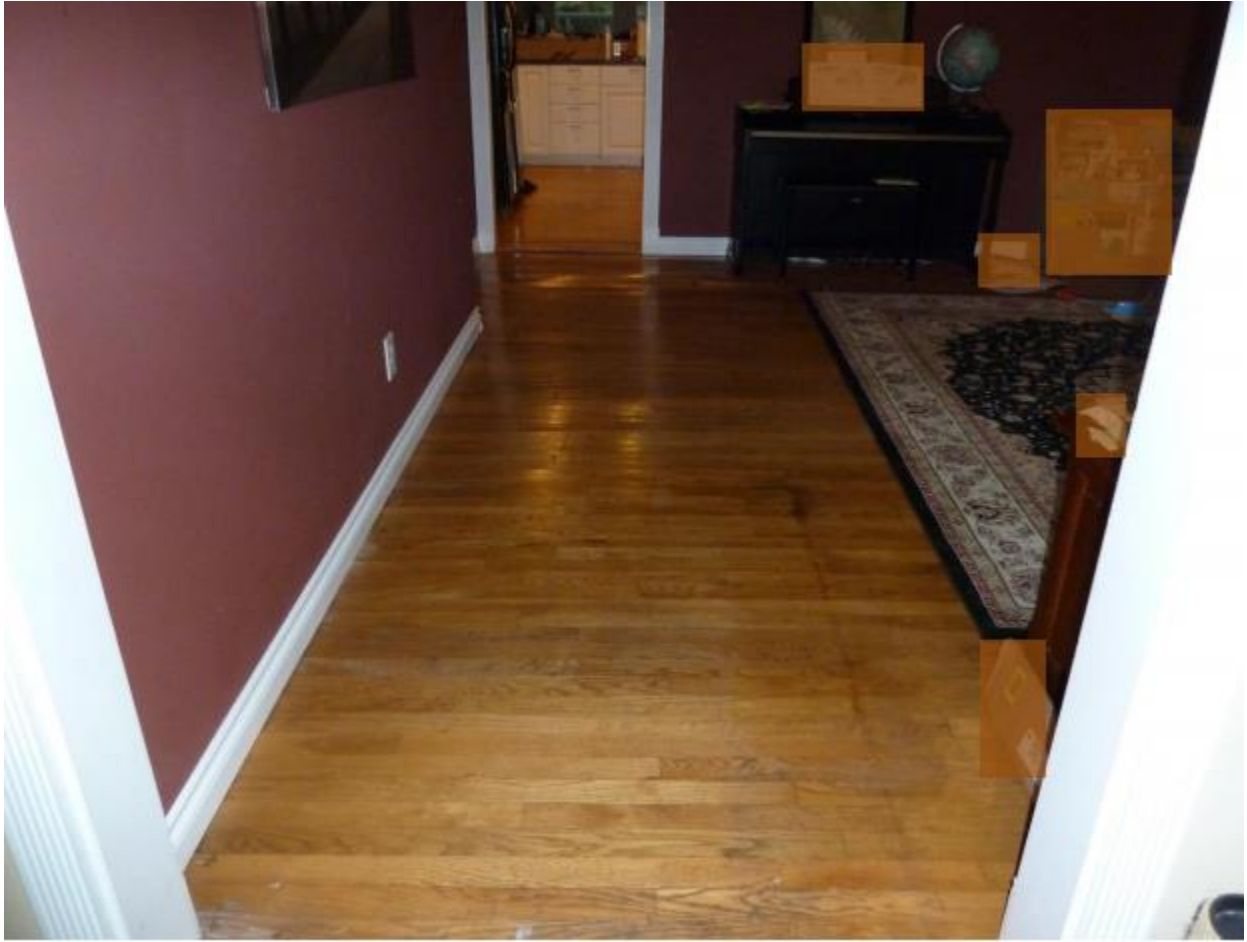
The break is in the kitchen area thru the opening in this picture. The floor was buckled from the opening in the picture all the way to the front door.

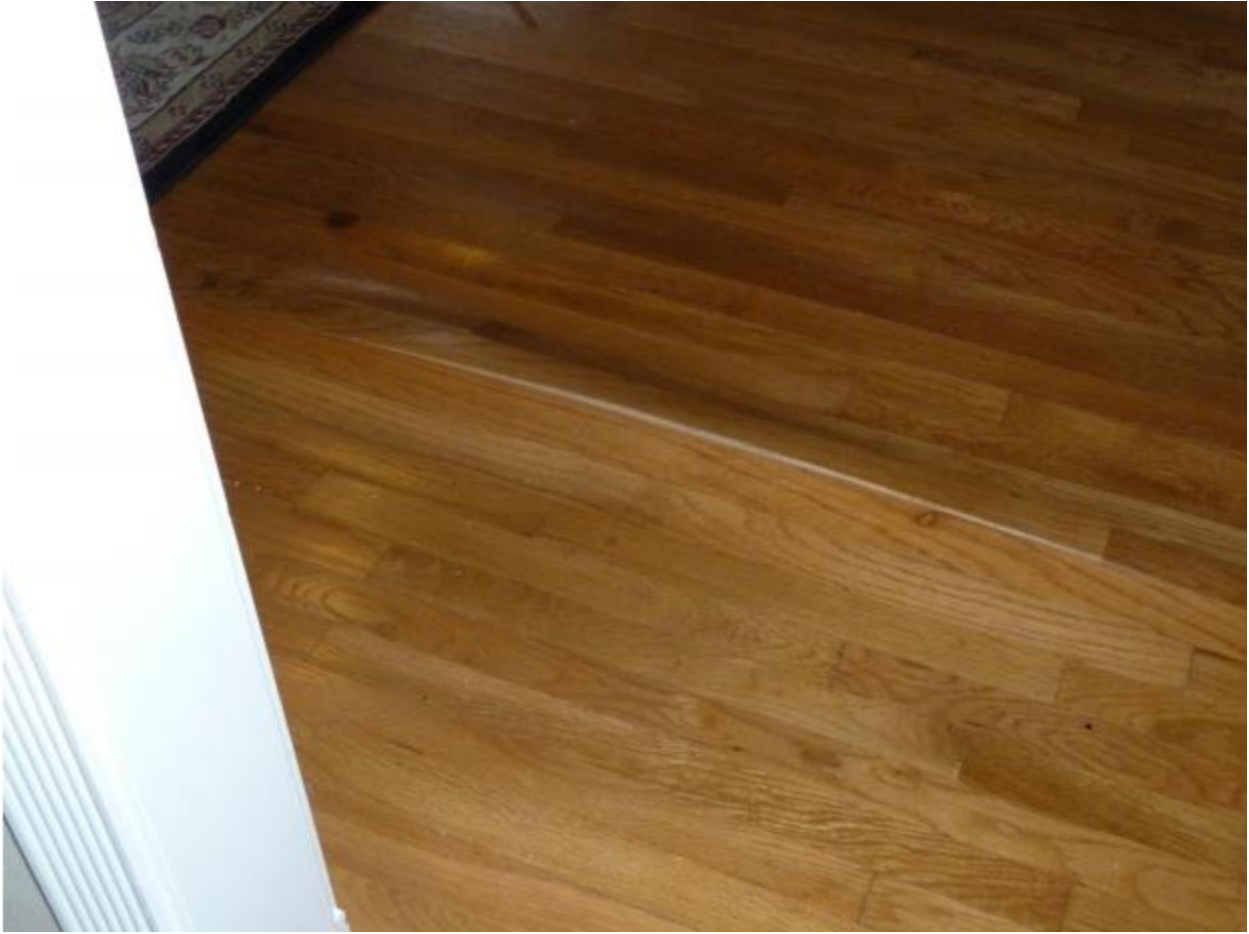
Same area

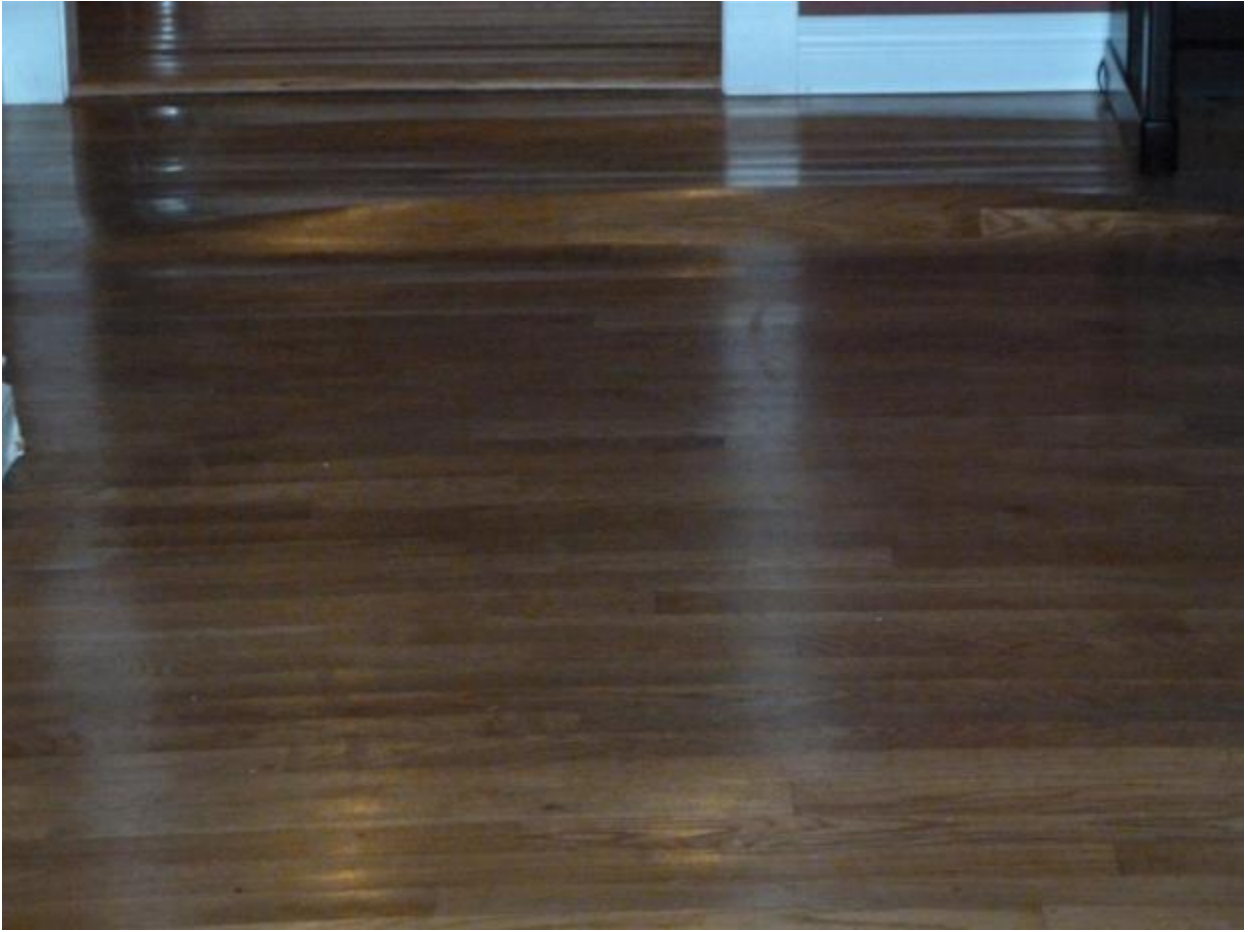
Looking into the Kitchen area.

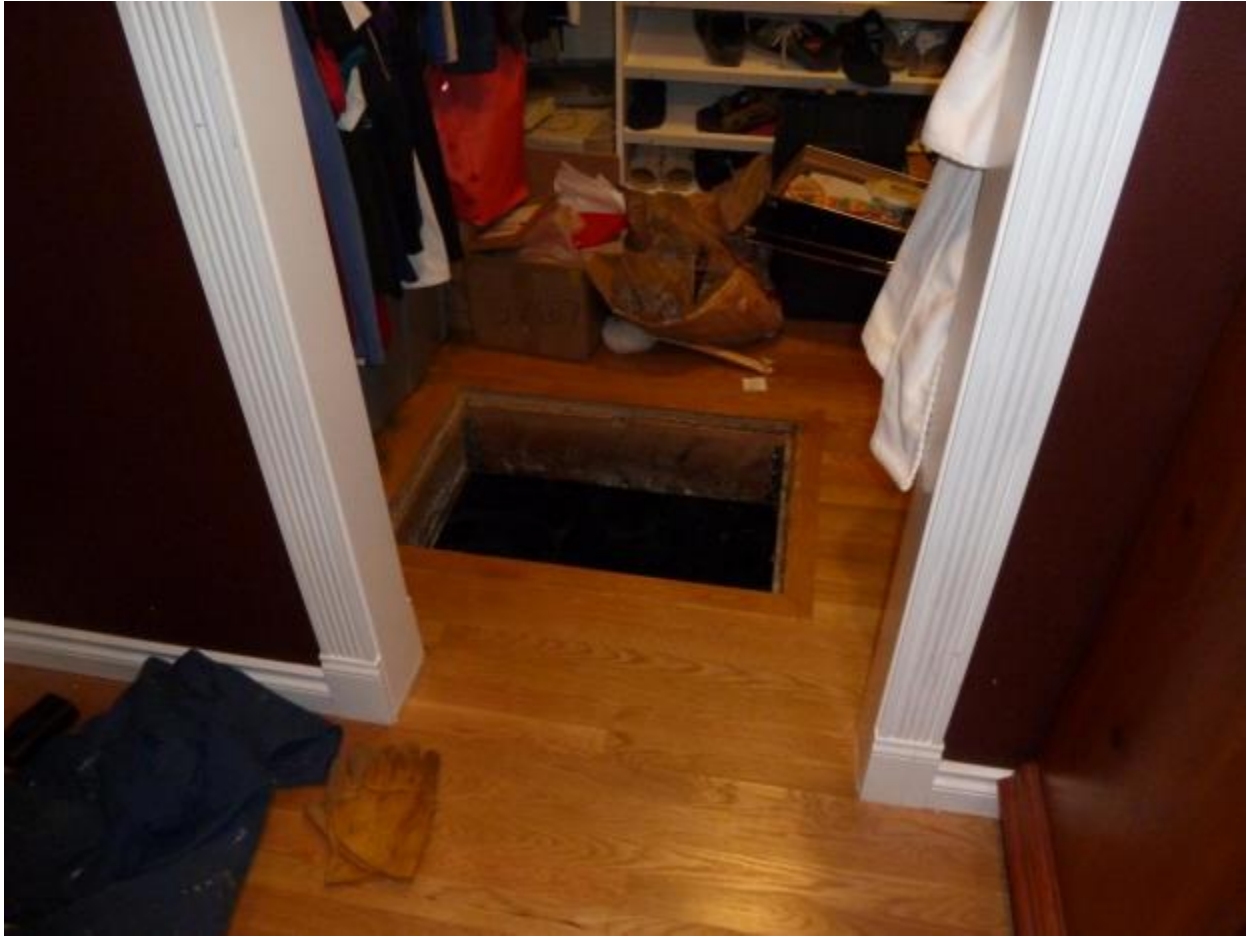
Crawl space opening .

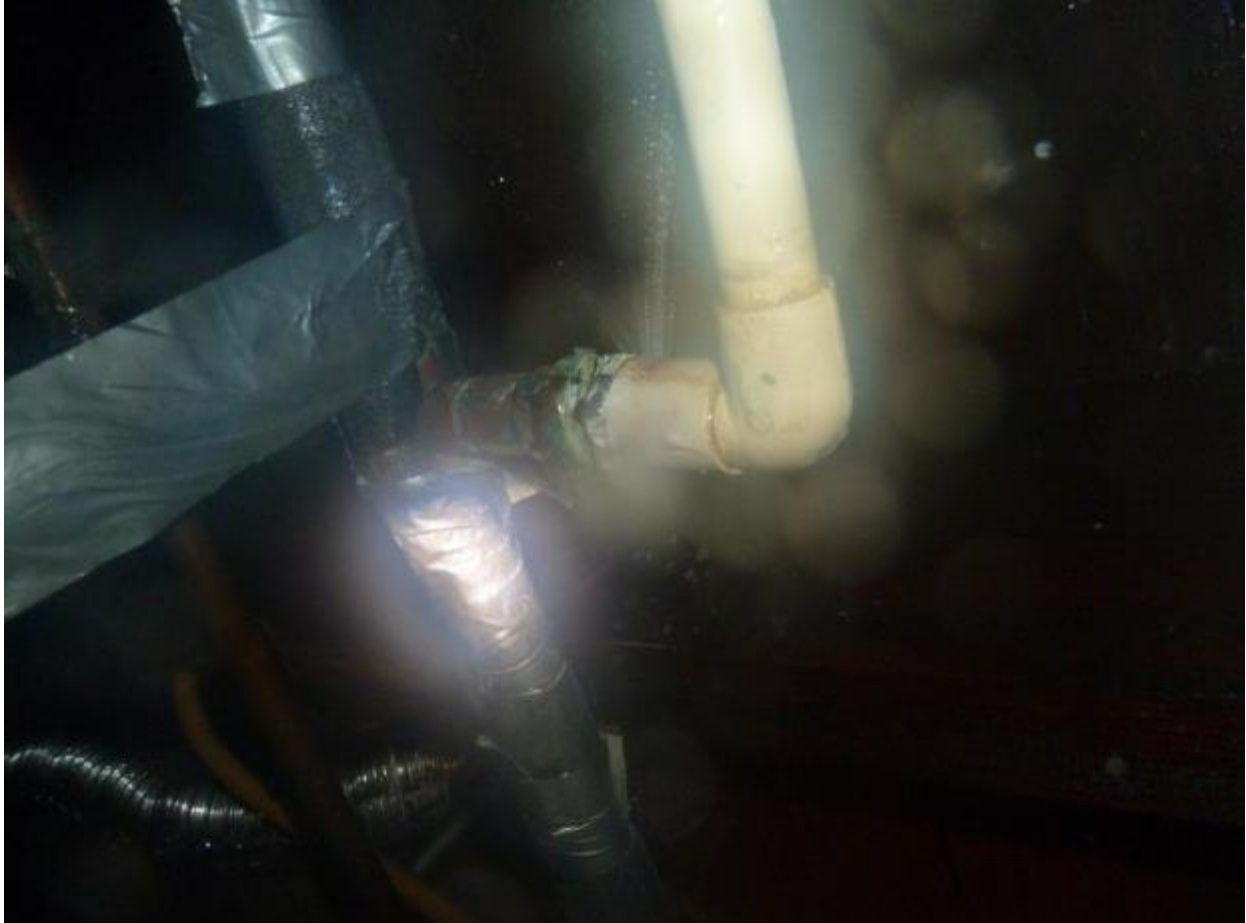
This is the pipe that had split, looks like a female adapter attached to a  $\frac{3}{4}$  in male adapter on the hot water supply side. The pipe has a split in it and is spraying directly up to the underlayment of the floor.

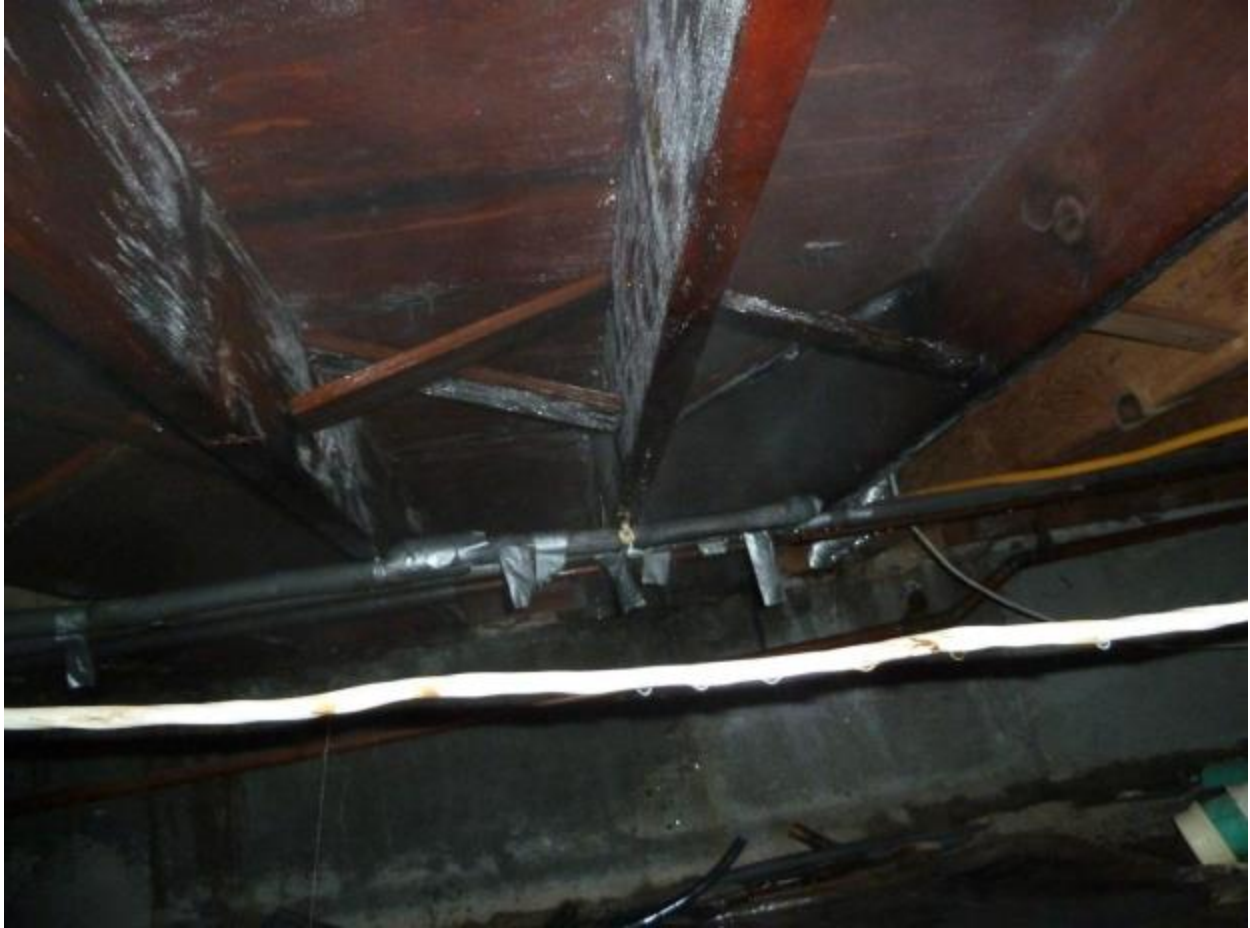
The same area looking over to the pipes. The black wrap is the new pvc line. There is no insulation so the wood really got wet.

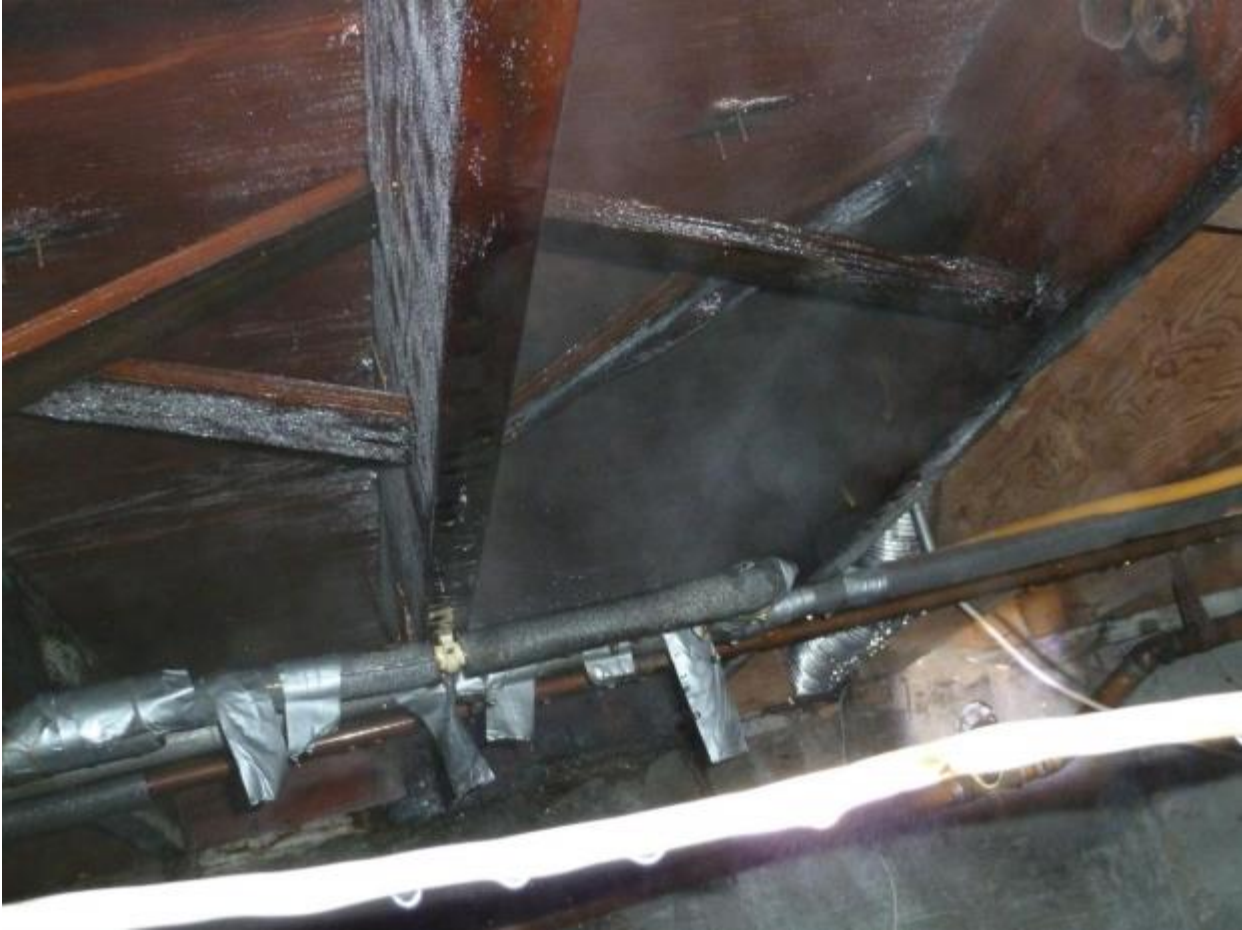
Same area. Showing the mist of the spray.

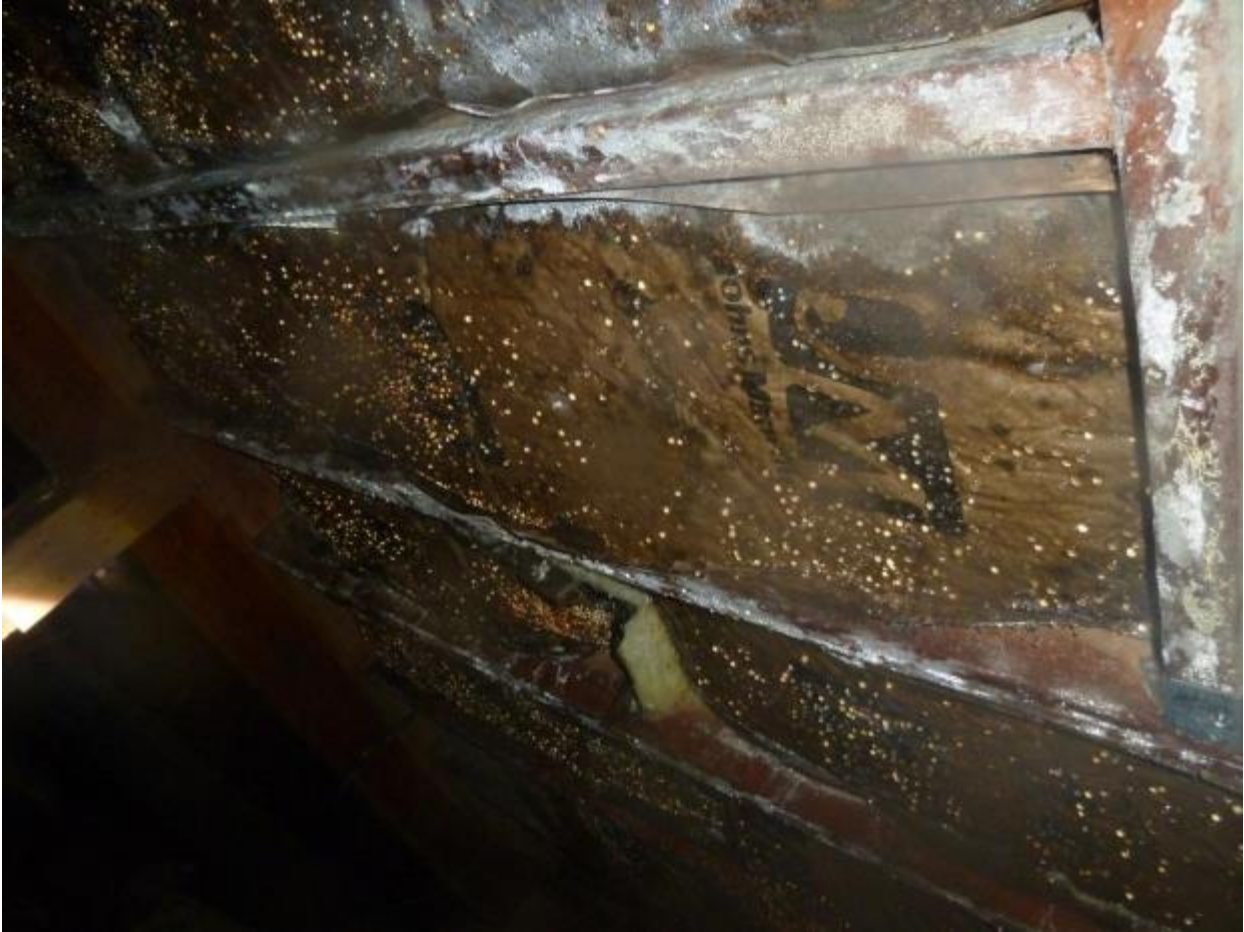
Moisture dripping from the insulation

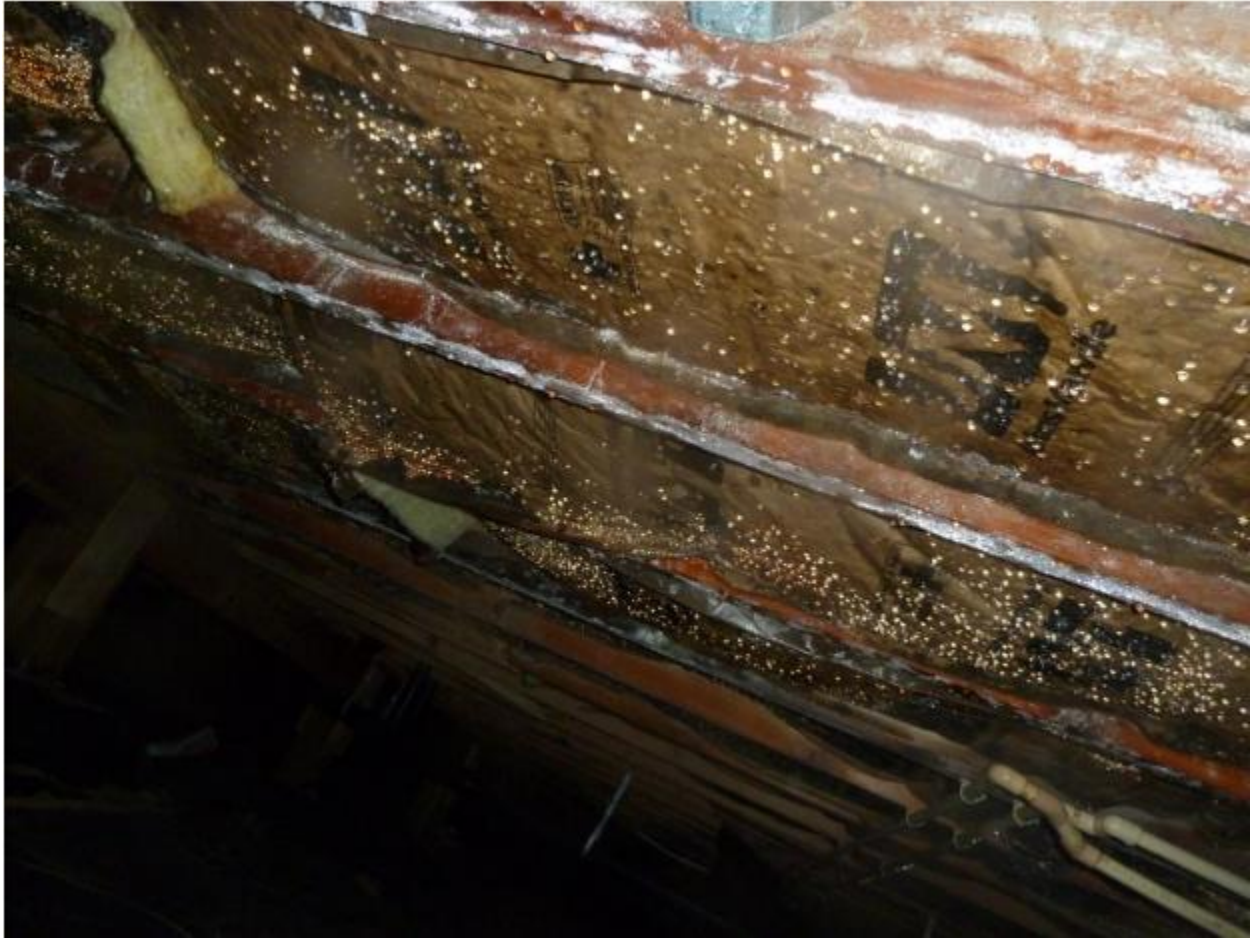
Same area showing dripping from insulation. It appears the  $\frac{3}{4}$  pvc pipe has a split in it where it connects to the  $\frac{3}{4}$  copper line. The renter says they saw problems at Christmas. So the leak could have started around that time or sooner.
