Claim #XXX-XXX-XXX-XXX

Seattle, Washington

From Leak Masters LLC

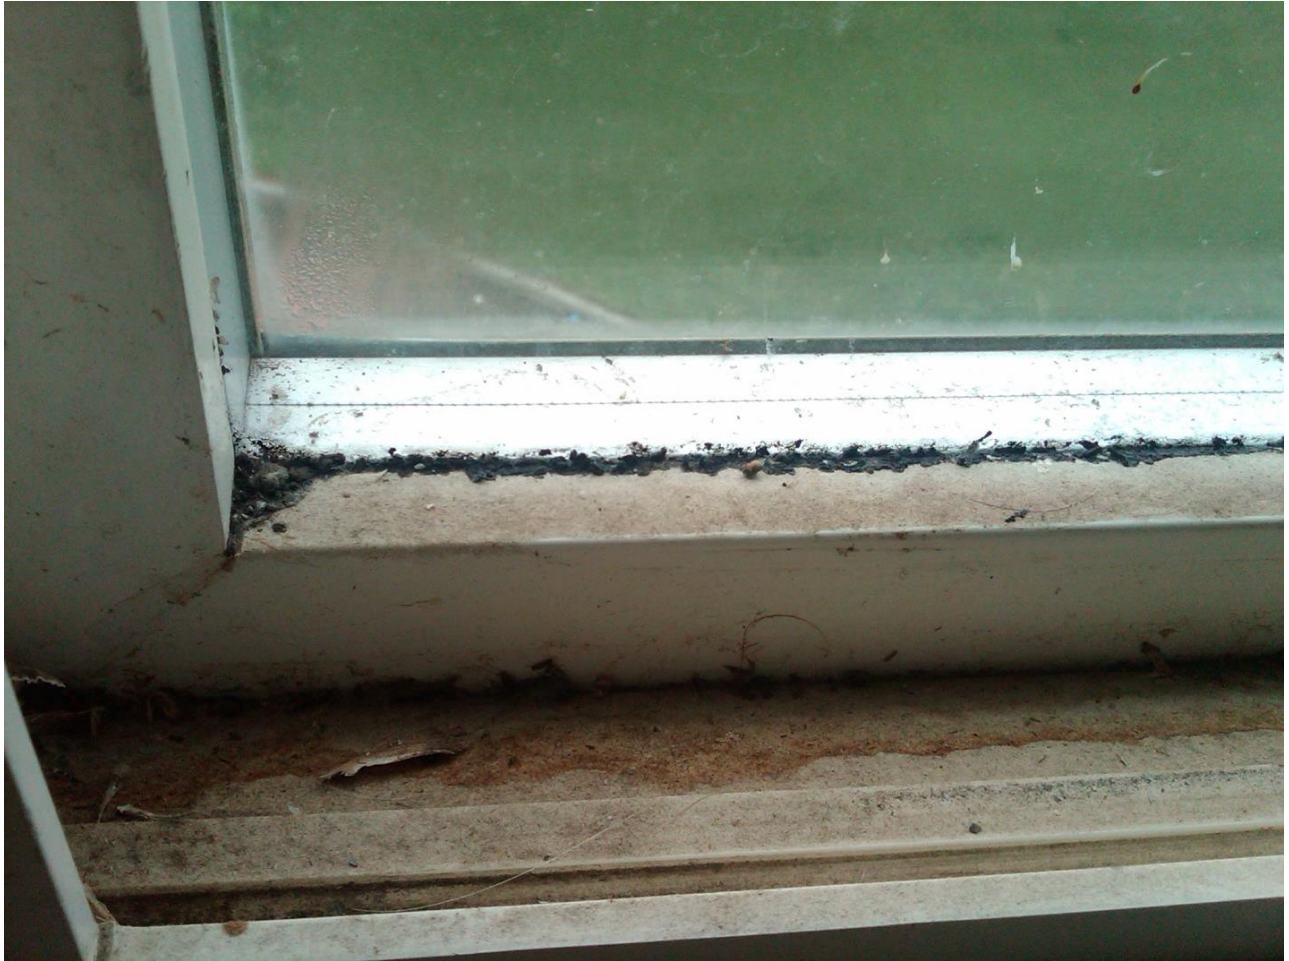
1. The upstairs master bedroom had water around the window sill. The window itself has a crack in it, which may let water in it. Also the siding around the window may have a broken seal from the caulking job. The picture is on the following page. The window has a small hole in it like from a small rock.

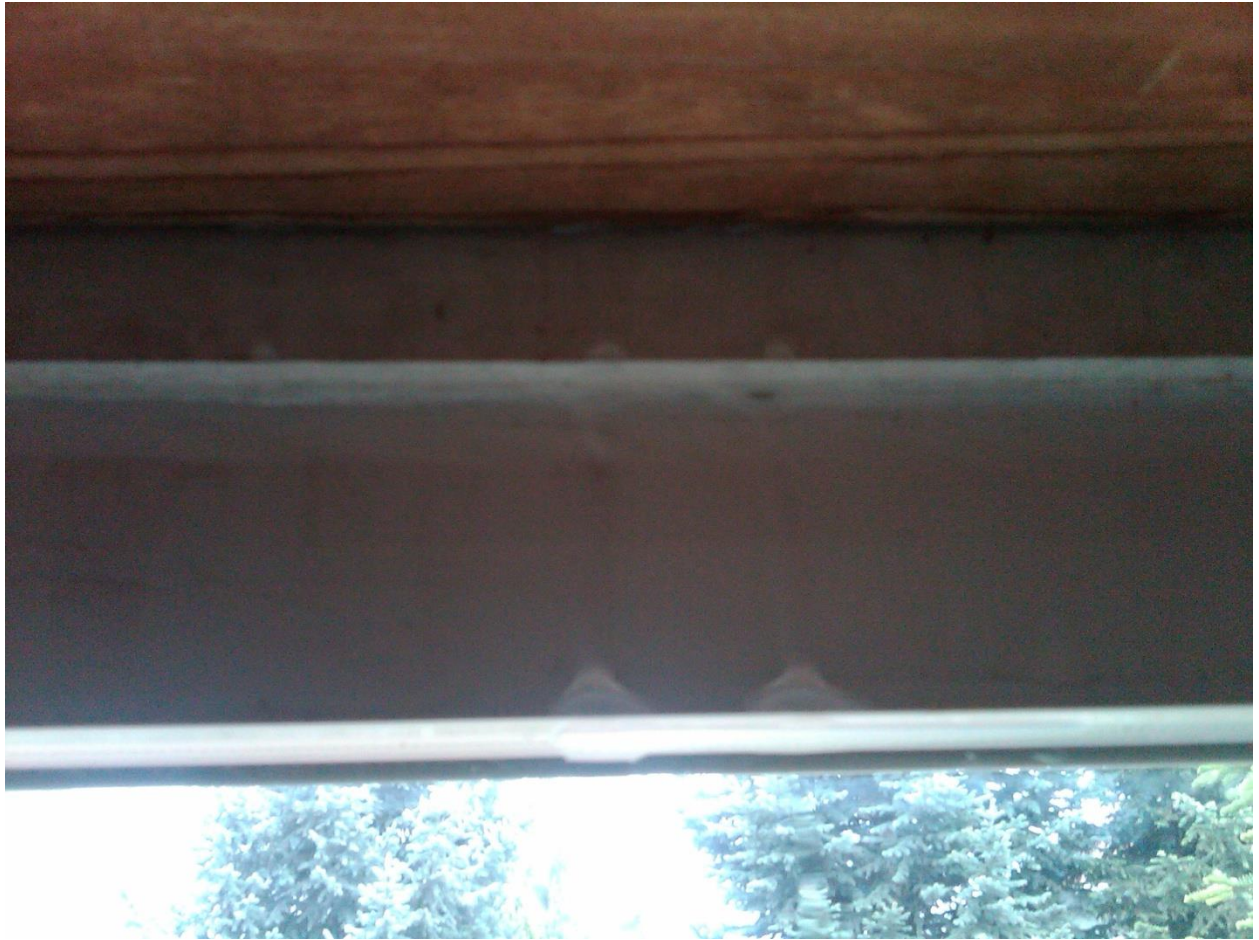
This is the slider to the backyard. There was a lot of water staining and dirt in the sill of this slider. The slider itself had a large crack in the plastic on the part of the slider that moves back and forth. I closed the slider and ran a small amount of water on the exterior of the siding to check the caulking and seals. The water ran inside of the house and down in the same areas that I had seen prior to checking it for leaks. This should be a water tight seal. So when it rains it would flow down and into the house.

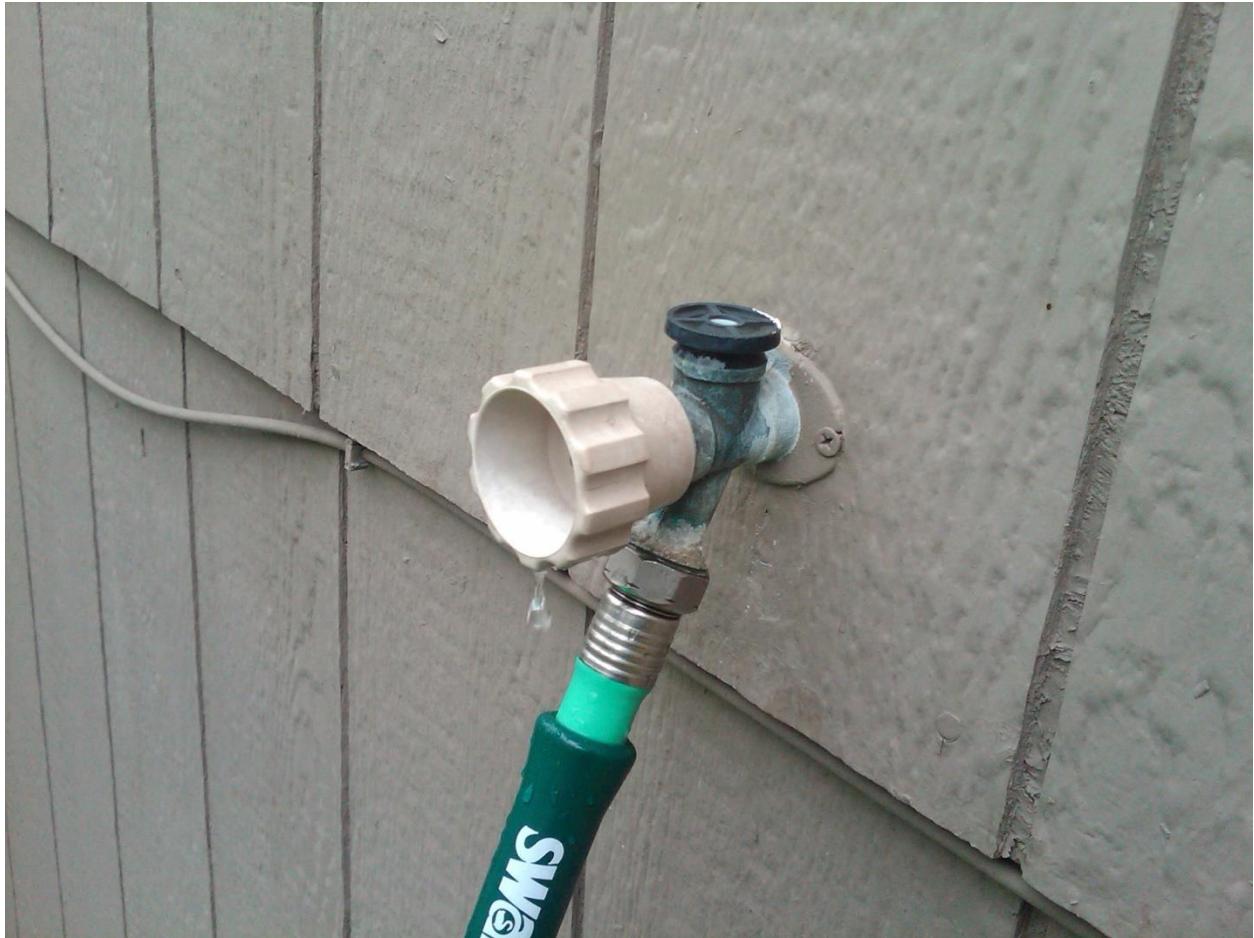
This picture is of the frost free hose bib to the front yard. It has a crack in it from being frozen. You can see a small amount of water running down it in this picture. If the homeowner turns this faucet on, it will run at full strength and most of it will run inside of the house and down onto the floor and all over the ceiling.
