# Leak Masters LLC

Claim # XXXX-XXXX-XXXX

CLAIMS ADJUSTER, I inspected this loss today, I found that the Garbage disposal has rotted thru and has holes in it. I found one area on the side where a temporary patch type material was applied. However the water still shoots out of it when any water is run in the right side of the two compartment sink. If the dishwasher is run it too would have the potential to leak out of the disposal. The dishwasher drain goes up to the air gap in the sink, and then down into the side of the disposal. It is plumbed correctly. The kitchen faucet also leaks on the top of the sink when water is turned on. This could be a second potential water source. The saddle valve that VENDOR NAME REDACTED tightened appears to not be leaking at this time. The wood in the bottom of the cabinet under sink is very wet, and is sagging down on the left side where a water filter container is sitting. I would say that this leak appears to be going on longer than a couple of weeks. The crawl space shows signs of water staining on several joists. The moisture meter

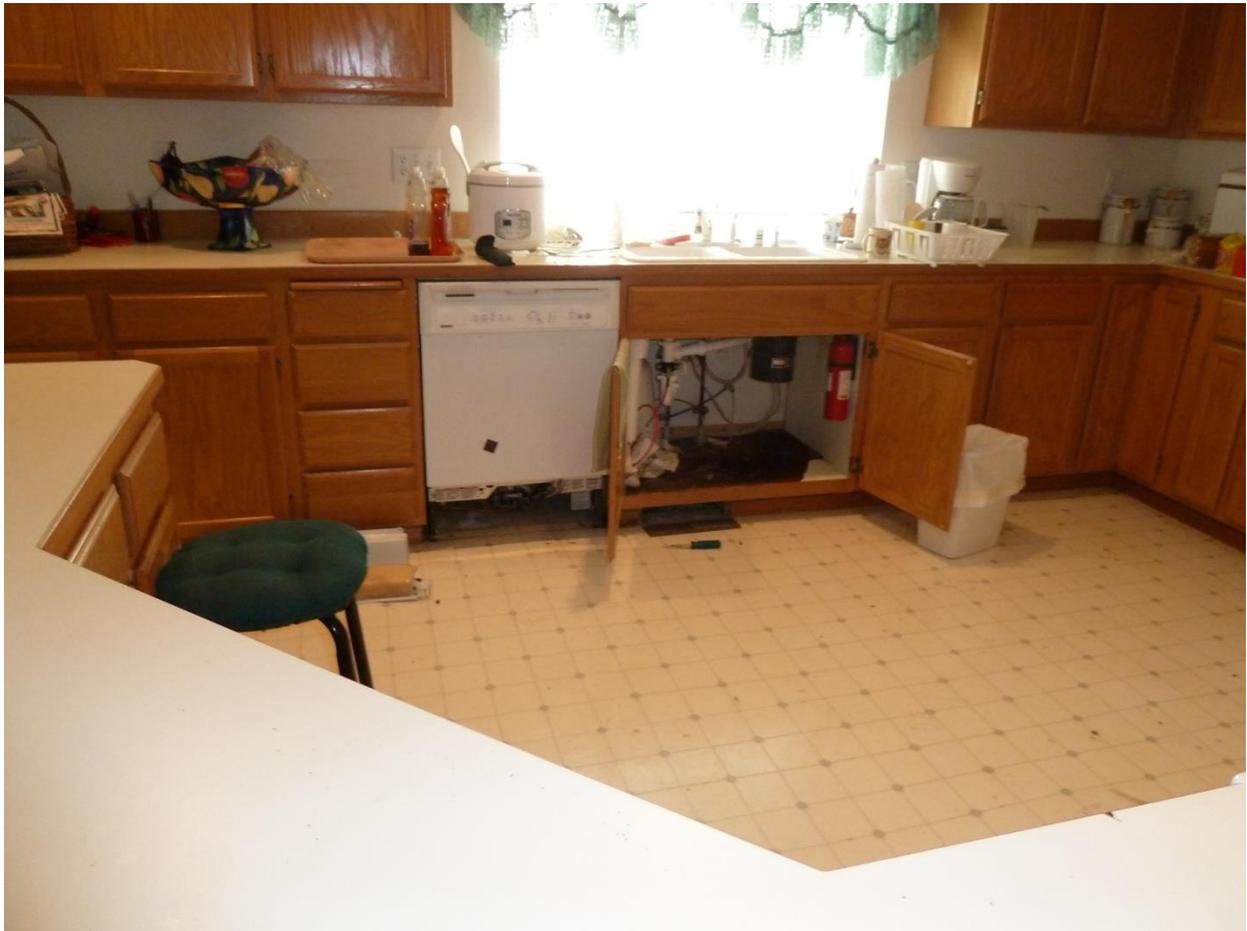
This is a picture of the kitchen area. There is a lot of moisture under the cabinet area, and also water wicking under the dishwasher. The back wall under the dishwasher show signs of moisture behind it. The floor in front of the dishwasher and also in front of the sink shows signs of swelling up.

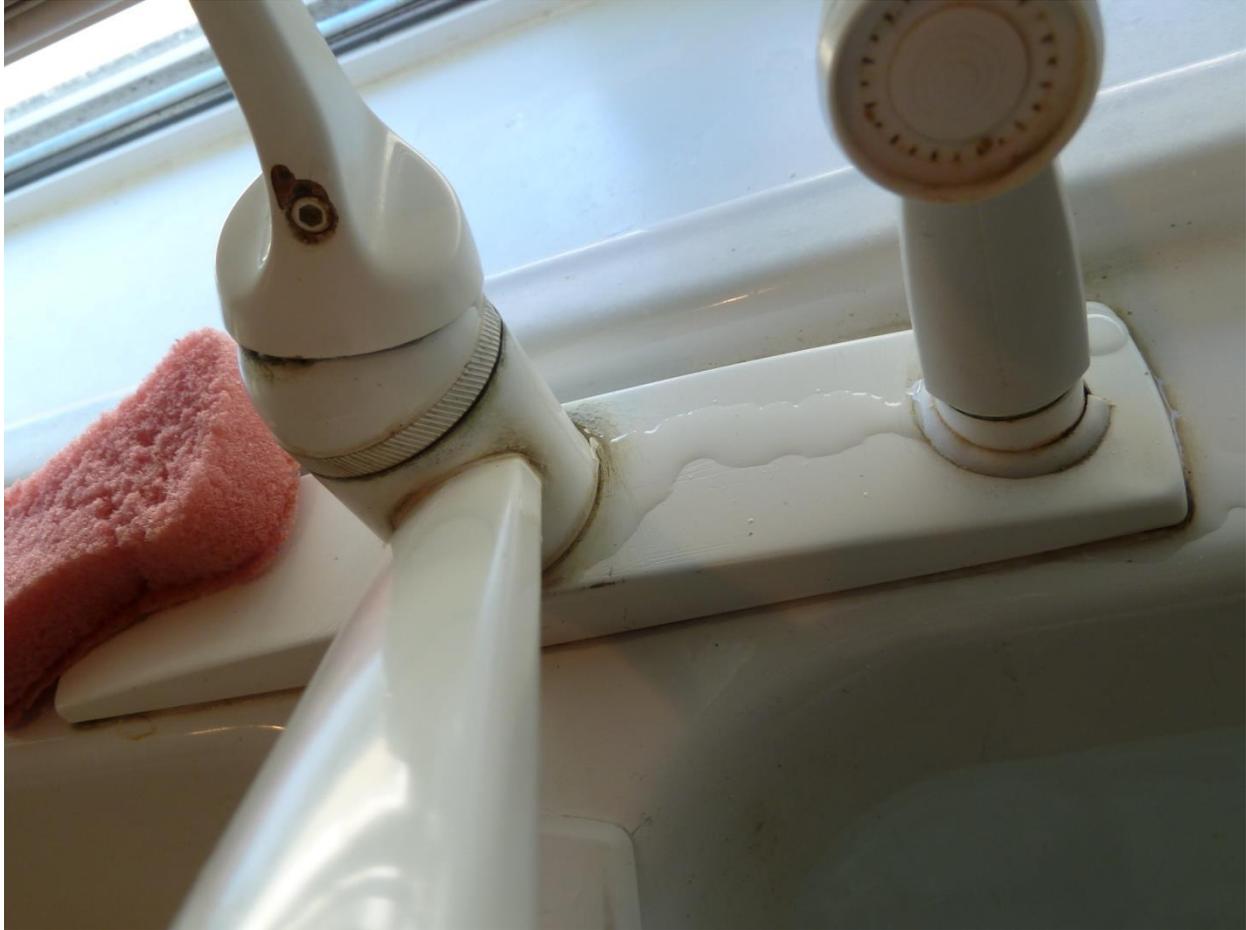
This is a delta faucet on top of the kitchen sink. The water flows out of the body and has the potential to drip down below on cabinet.

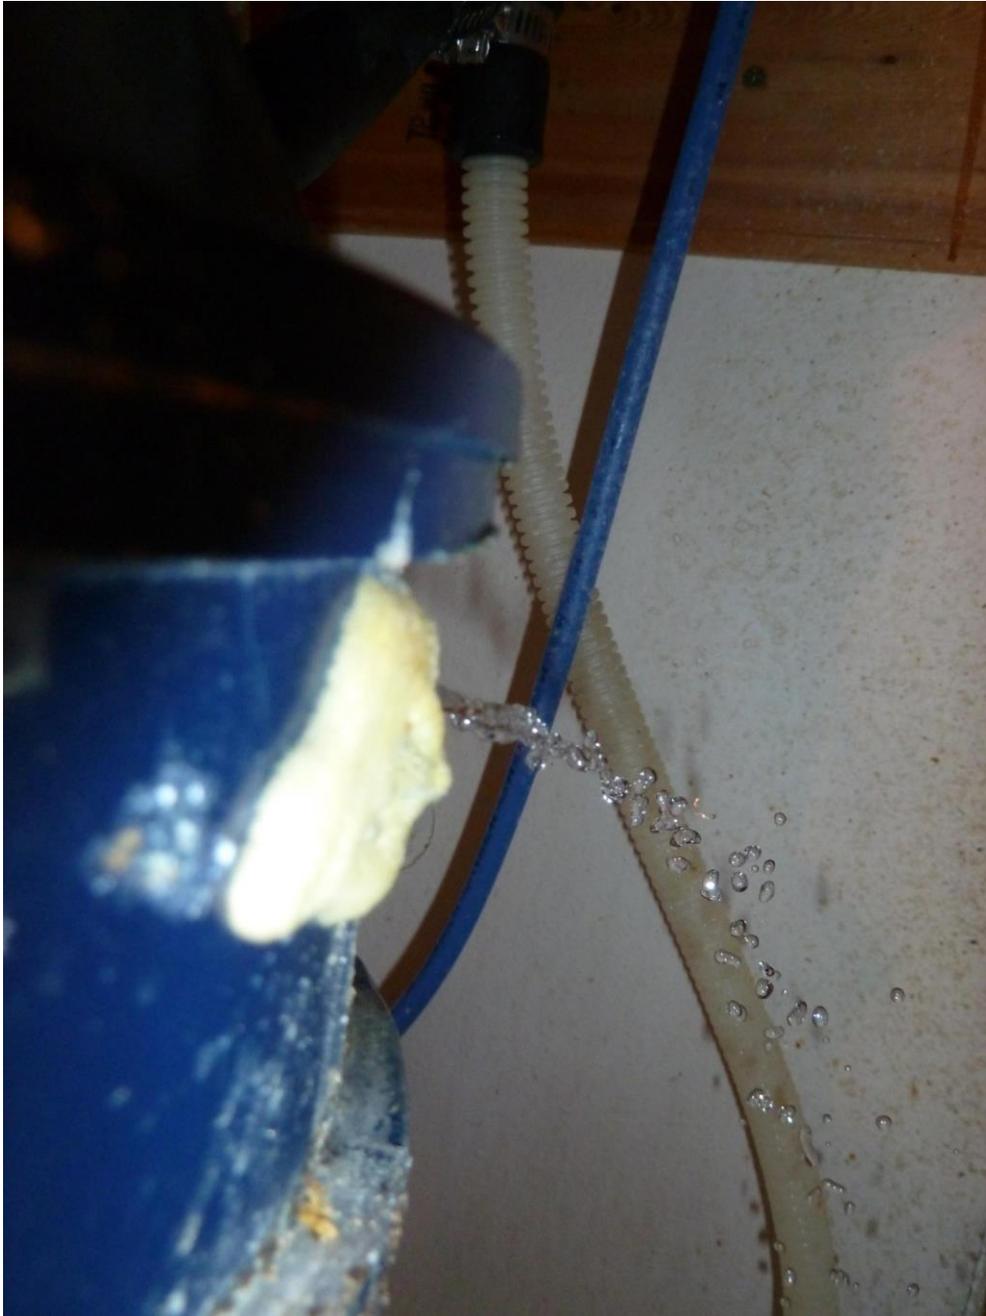
This is the side of the disposal; you can see the white yellow looking material and the water shooting out of the side of it. The disposal appears to have rotted thru the side. When the dishwasher is run it would also have the potential to flow water out of the holes.

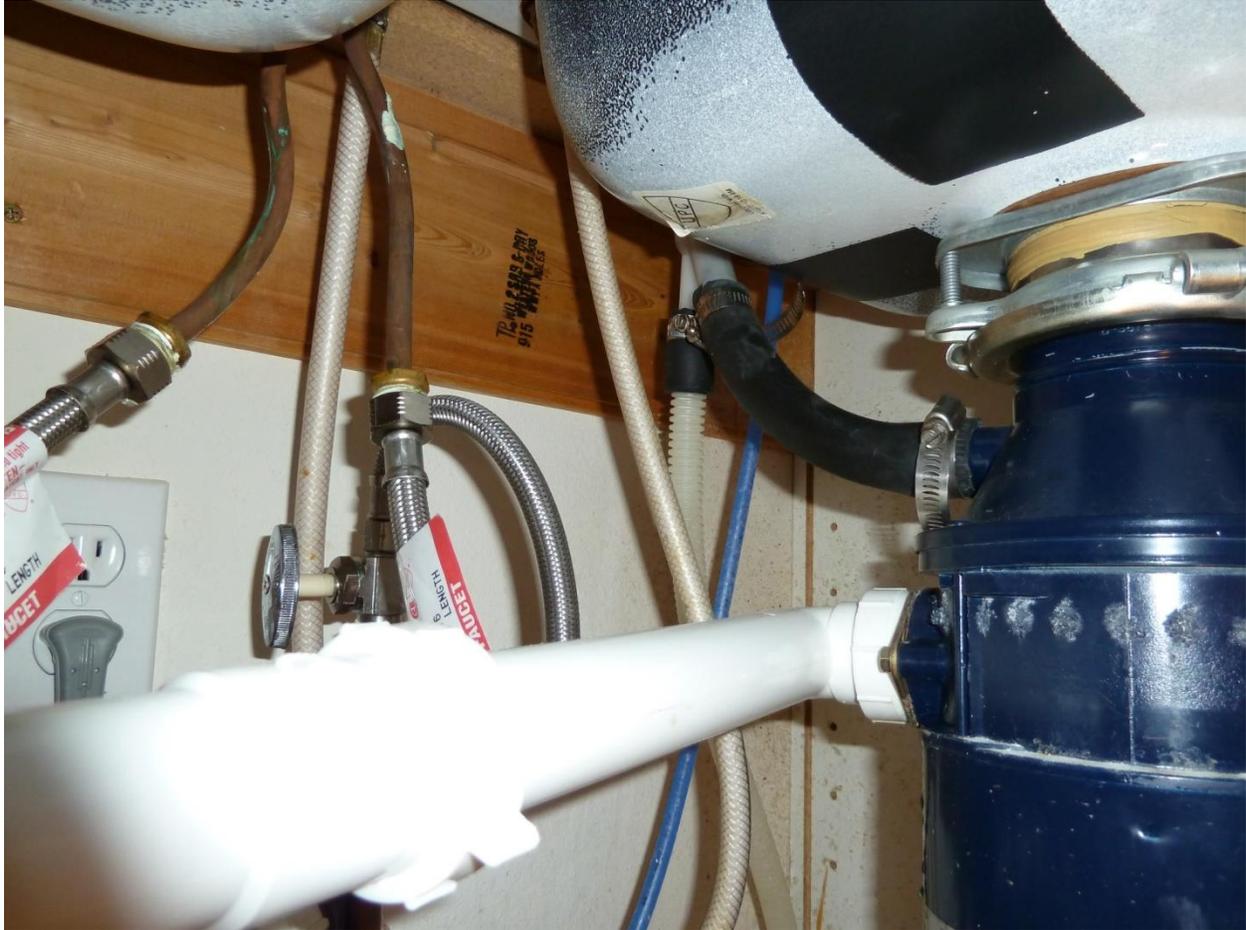
Also if any water would be run in the sink on the right hand side it would also have the potential flow out of these holes. You can see some white discolored staining on the disposal going around it in small circles. It looks as if the disposal is rotting out. The other side has large holes in it. The black pipe in the picture is the drain going into the disposal from the air gap. That leads from the dishwasher.

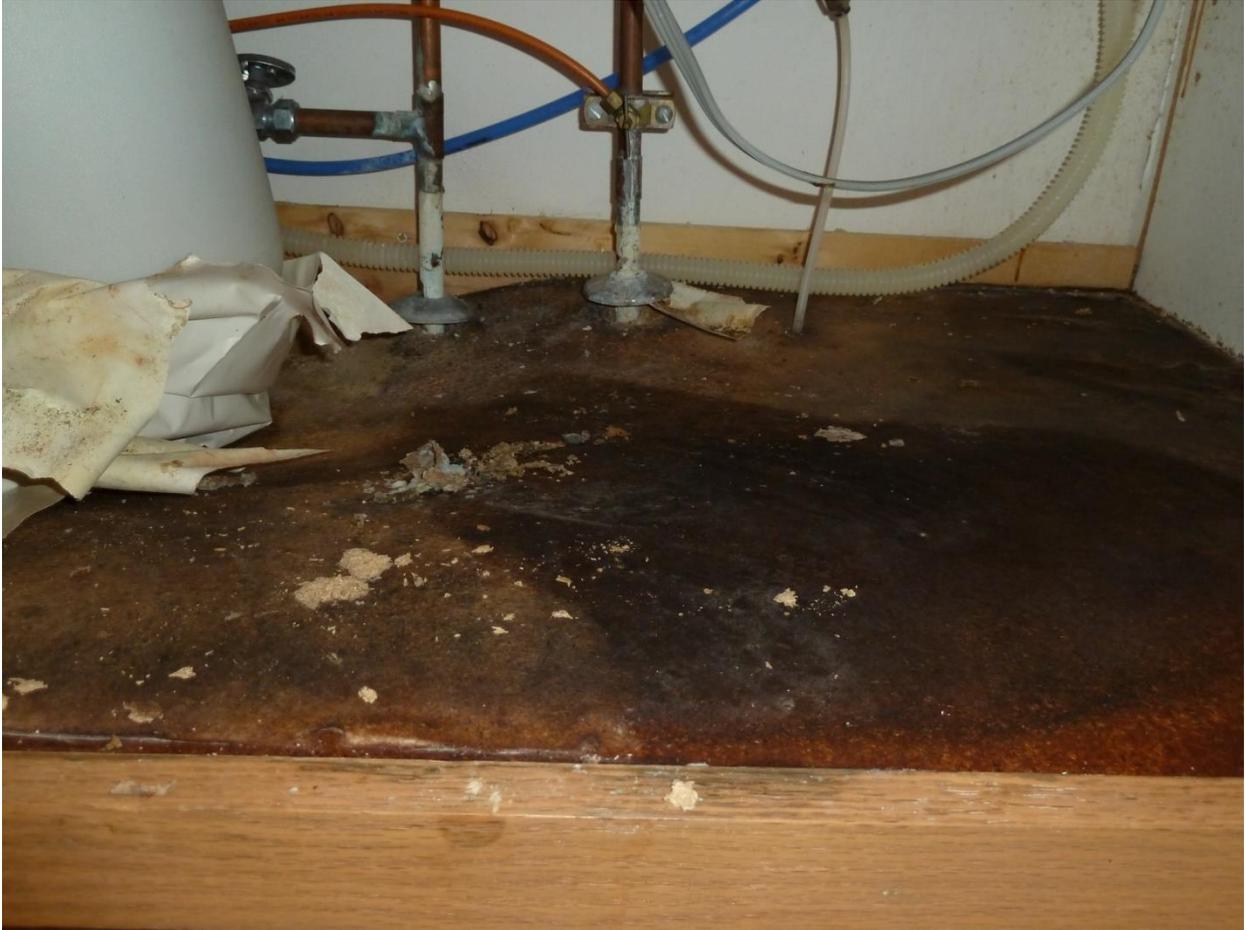
This is directly below the sink; you can see the wood that has fallen down on the left side, and the moisture on the right. The pipes in the back on the right side looks like the needle valve or saddle valve that had a leak on it previously.

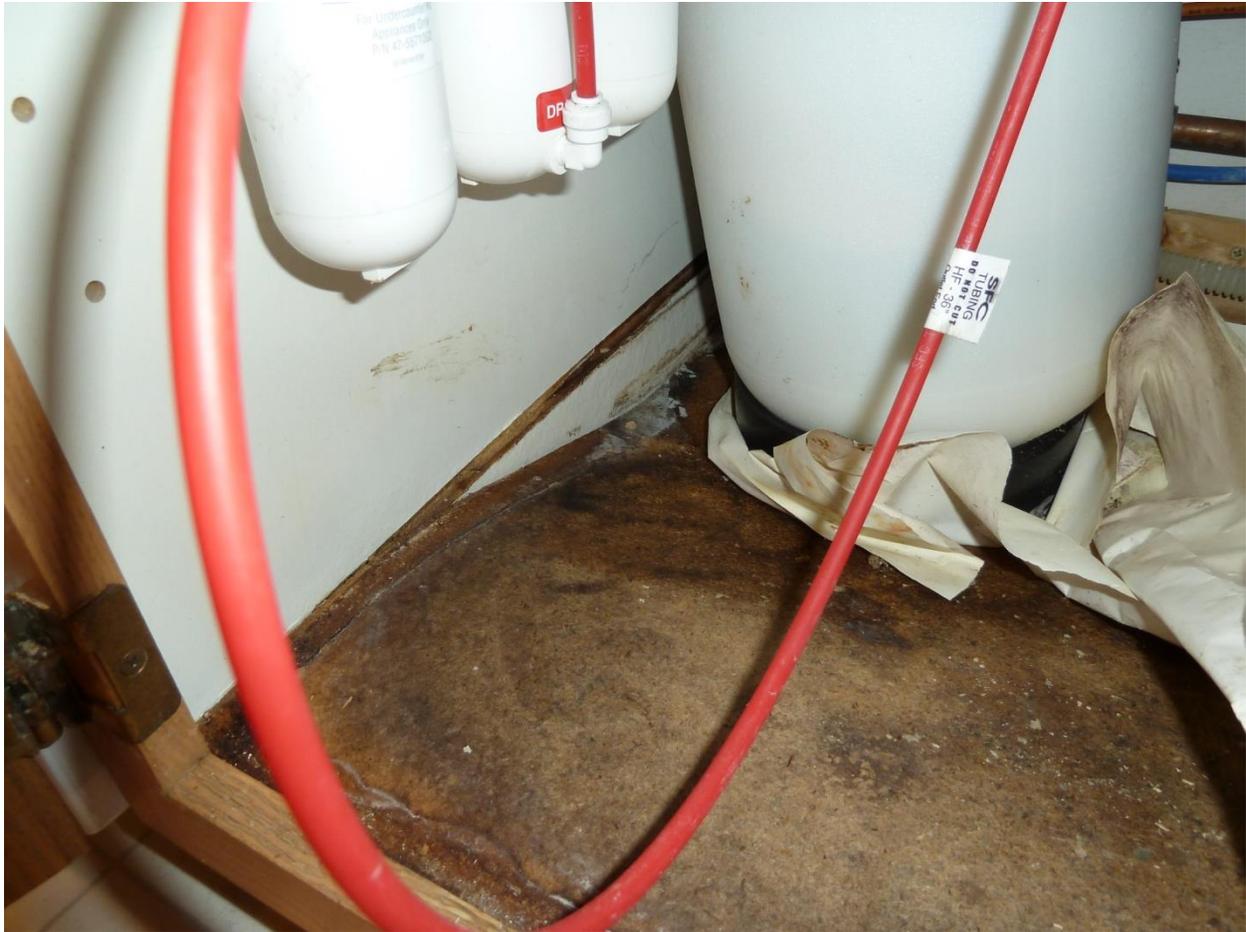
This is the left side of the cabinet under the kitchen sink. The wood is almost collapsed down. The only thing holding it up is a metal duct for the heating that is run under the cabinet.

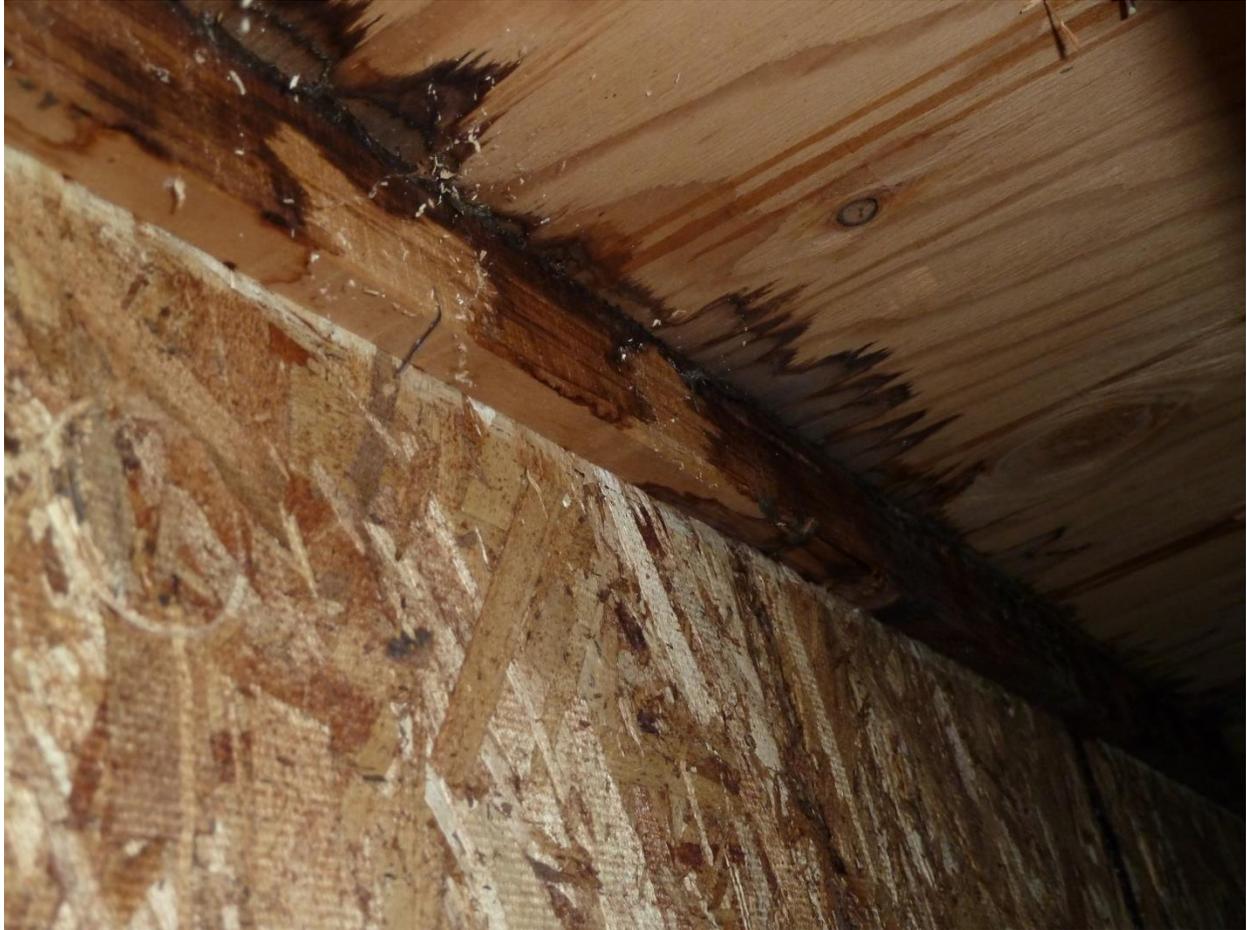
This is in the crawl space below the kitchen sink area. You can see the staining on the wood. The water would wick out from the sink area and looks to travel across the kitchen area under the vinyl flooring.

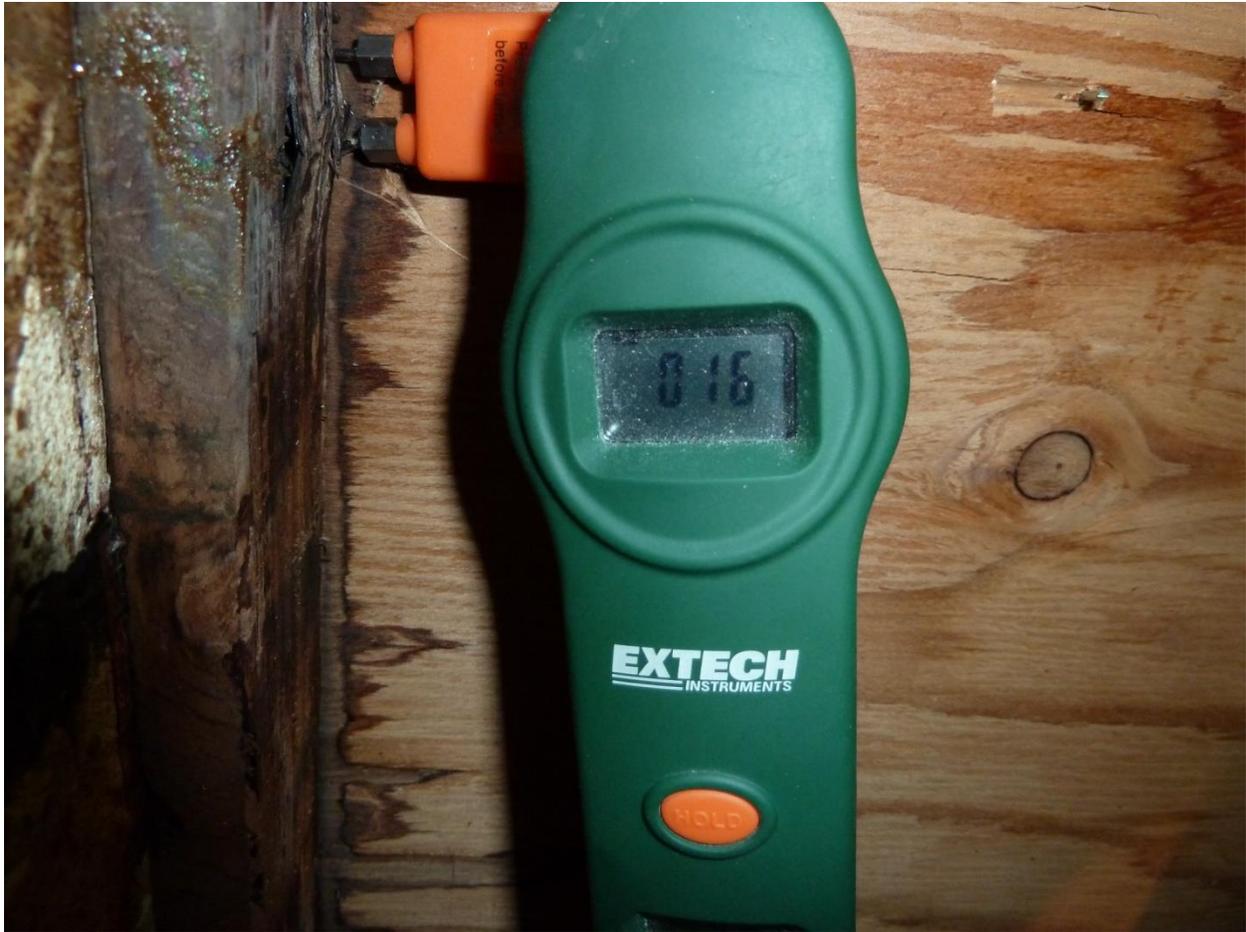
This is the area from the previous picture; you can see the reading on the meter. This is in the crawl space in front of the kitchen sink area.
